**3000-HP ROLLER GEAR TRANSMISSION DEVELOPMENT PROGRAM
Volume VI - Reliability and Maintainability Report**

Sikorsky Aircraft
Division of United Technologies
Stratford, Conn. 06602

January 1977

Final Report

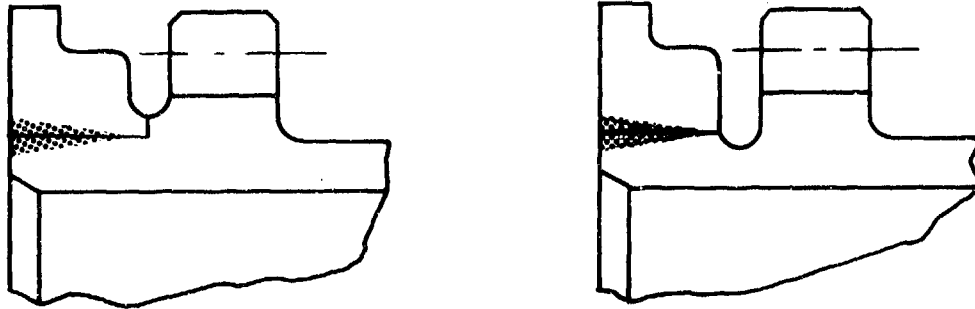
Figure A-4. Initial and Modified Weld Root Relief.

The initial weld configuration incorporated an undercut between the roller and gear shaft to accommodate weld splatter. However, when the weld did not fully penetrate into the undercut, voids remained at the root of the weld, lending incomplete fusion of the joint. To eliminate the stress risers that this induced, the root area of the weld was removed as shown in the modified configuration (Figure A-4).

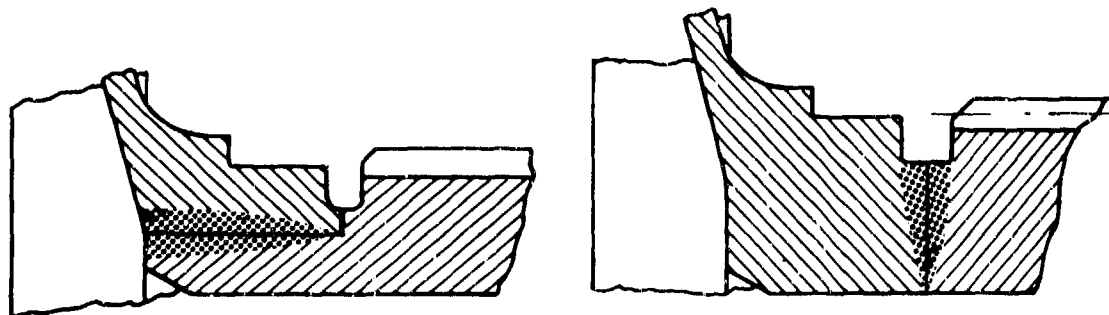
Figure A-7. Weld Configurations, First-Row Pinion.

The initial design of the first-row pinion was configured with a longitudinal weld to join the outer gears to the inner gear (Figure A-7). However, initial development testing resulted in fracture of the small diameter roller, and it became apparent that the weld was too deep for the constraints imposed. To increase the depth of weld penetration would induce too much heat and temper the case-hardened surface of the roller, thereby reducing the required R_c 58-64 surface hardness. A butt-welded joint was designed which eliminated the problem.

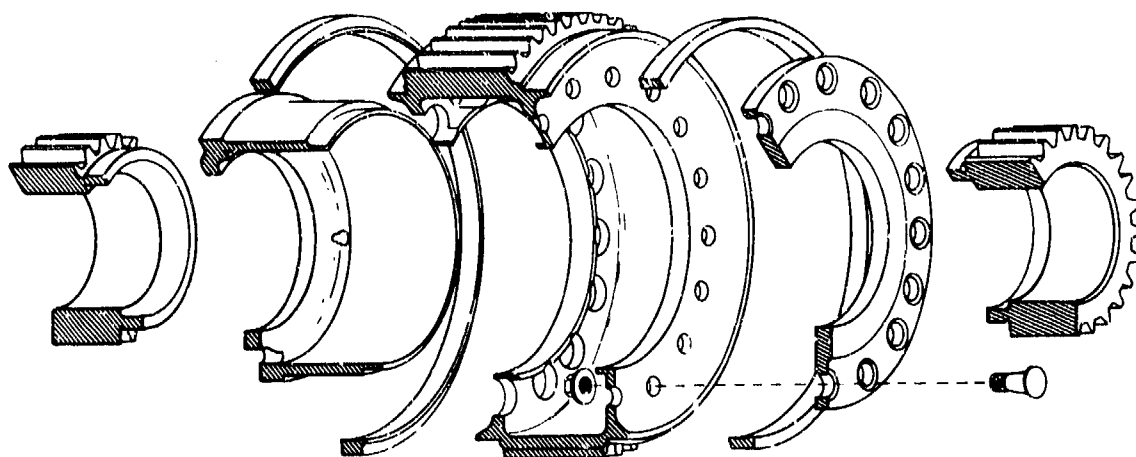
Figure A-9. Second-Row Pinion Initial Design, Exploded View.

The initial pinion design, shown in Figure A-9, consisted of an assembly of seven fabricated parts: two identical ex.3 gears, two rollers, a central shaft, a center gear, and an end flange bolted to the center gear web by taper-shank bolts. Fracture at the root of the weld between the central shaft and gear flange during bench testing, (8) necessitated the redesign of this gear.

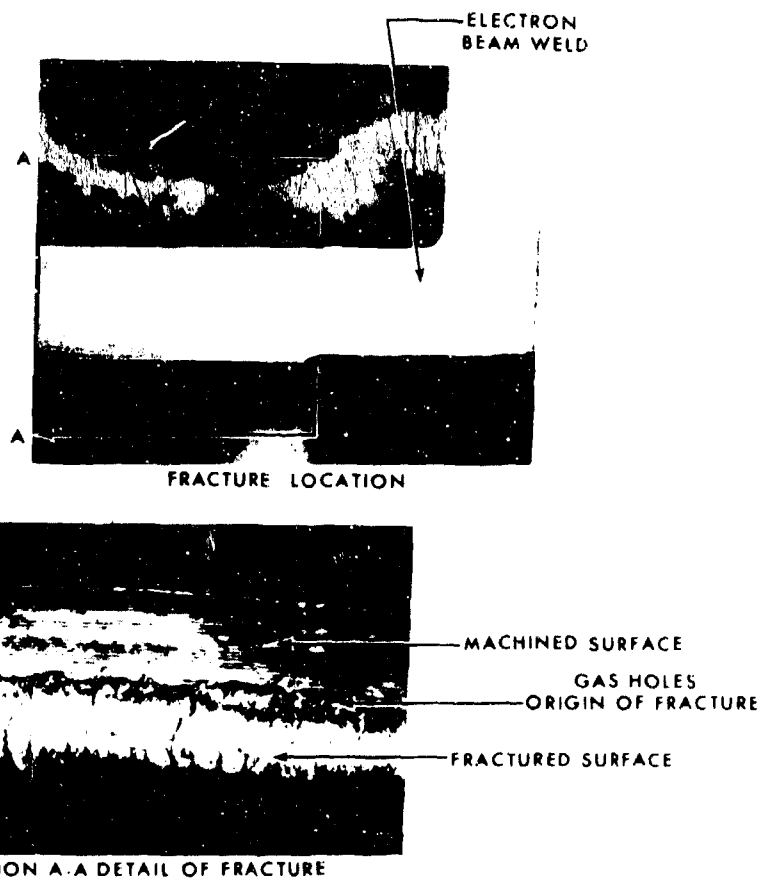
Figure B-9. Fracture Location.

A replacement for the dissected pinion was obtained, and the roller gear unit was subjected to further testing in the reliability and maintainability test facility to obtain crack propagation rates for the "cracked" roller welds. Ultrasonic inspections at 15 and 25 hours test time (at 3000 hp) showed no significant increase in flaw size. At 57:45 hours test time, fracture of a second-row pinion occurred (Figure B-8). Examination revealed that initial fracture occurred at the bearing bore weld, Figure B-9, and a secondary fracture occurred in the area of the outer roller weld due to the large

leverage load from the unsupported ring gear mesh forces. Ultrasonic inspection of the roller welds revealed no significant increase in the size of the flaws under investigation. This fracture of the second-row pinion resulted in a redesign of the second-row pinion. Testing of the roller gear units with the incorporation of this latest design pinion continued in the reliability and maintainability test facility.

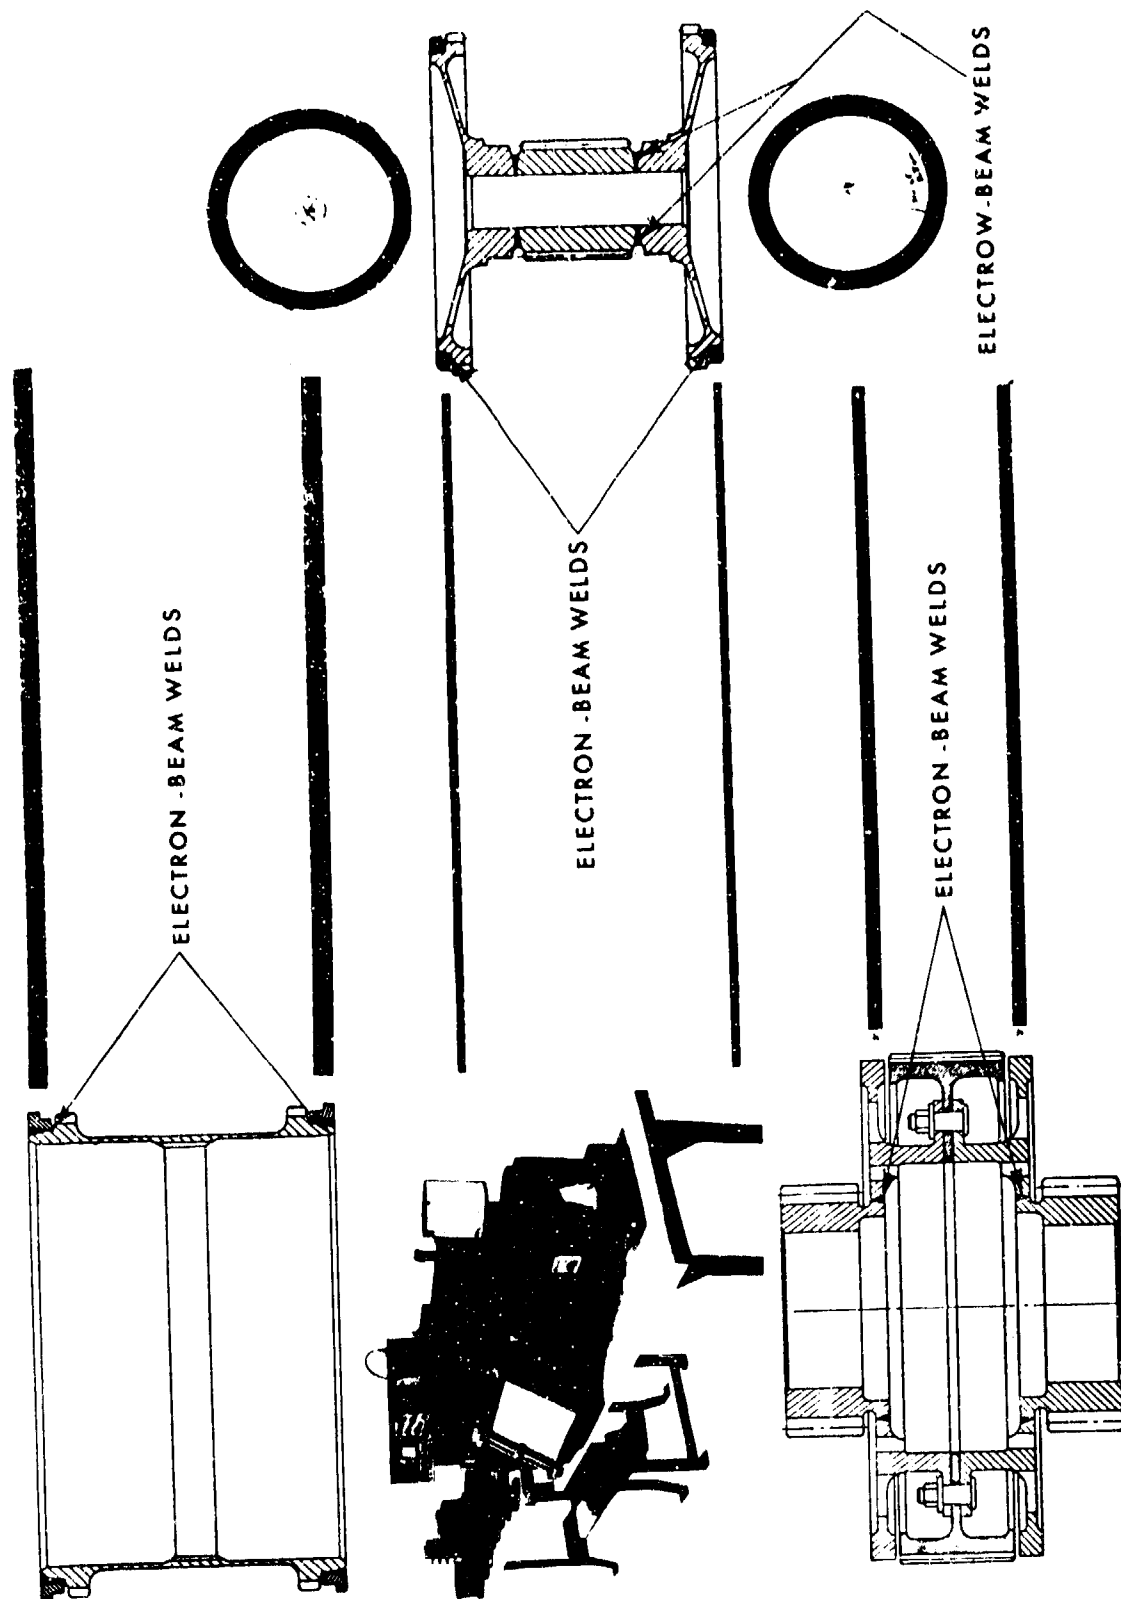
Figure C-28. "C" Scans, Electron-Beam-Welds.

Ultrasonic inspection of the electron-beam welds in the sun gear and first- and second-row pinions showed no degradation when the C-scans were compared to those obtained prior to the start of testing.
